City of New Haven
Historic District Commission

Application for
Certificate of Appropriateness

Russ Ekstrom / Jacqueline Hyde, LLC
19 Howard Avenue (83 South Water Street)
New Haven, Connecticut 06519-2808

Summary: Scope of Work

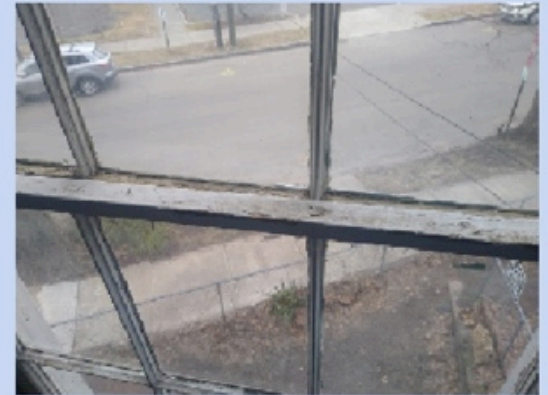
The bedroom windows are single-hung 6/6 wood sashes (not original), which are the only windows on the second floor that do not have (aluminum) storm windows on the exterior. They have, therefore, been subject to a great deal of weathering and rot over the years, and cannot be rehabilitated to any effective degree. One window faces Howard Avenue to the west, one faces South Water Street to the south, and one faces 81 South Water Street to the east.

(The east facing window will be replaced with a double-hung, per building code, to allow a fire egress onto the roof of the first floor extension outside of it.)

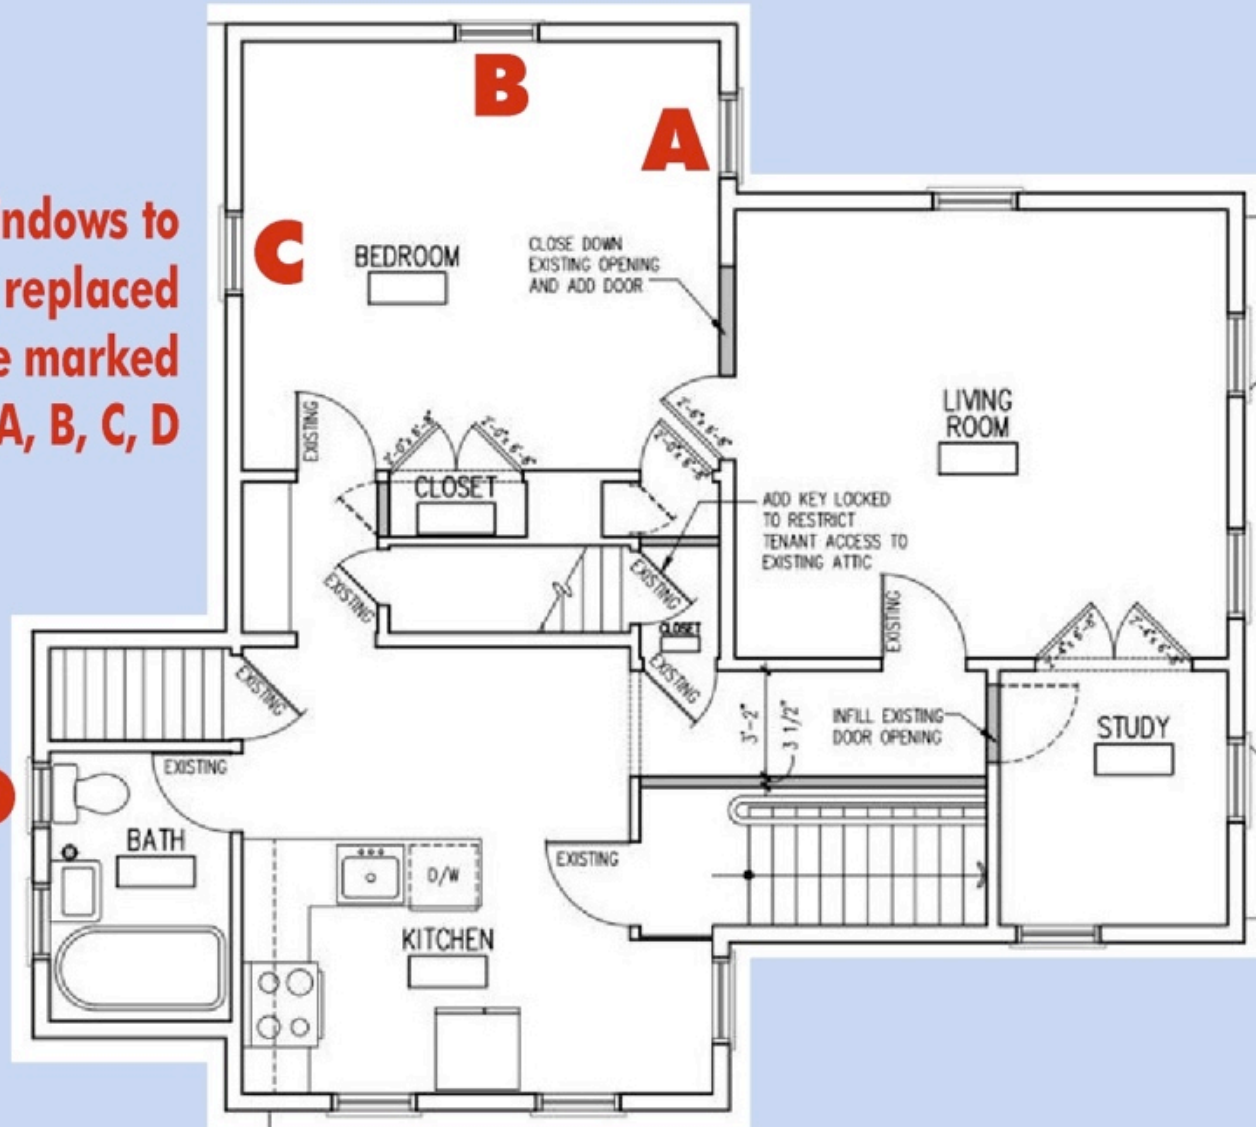
Windows to be replaced are marked A, B, C, D

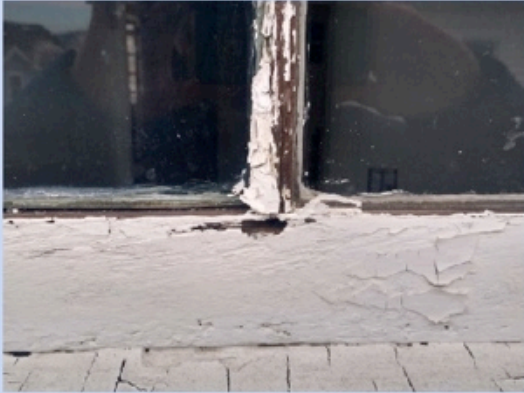
Exterior weathering
and rot to sash

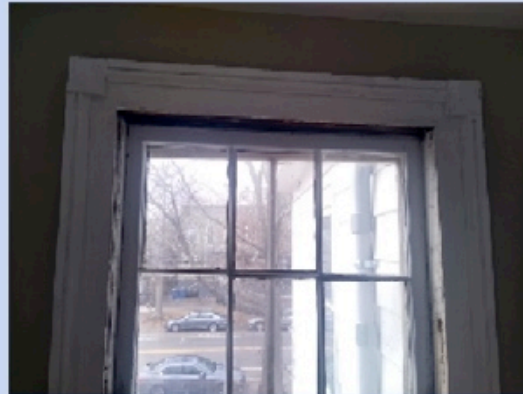
Out of square
(see gap at upper left)

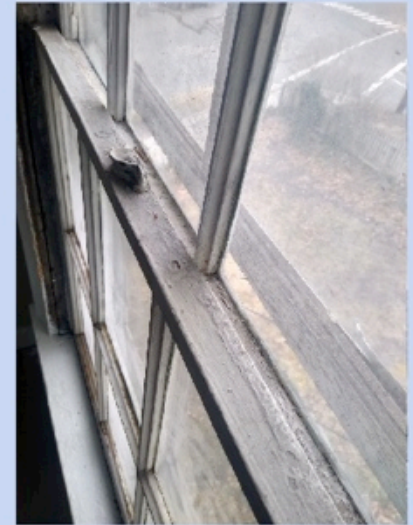
Misaligned meeting rails

- All of the meeting rails are misaligned, such that sash locks would need .75” to 1” of shimming to latch the window. Unless windows grow or casings shrink, this would support the conclusion that these sashes are not original to these casings.

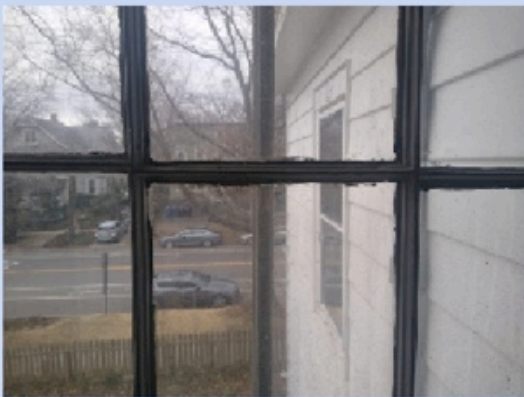
Misaligned mullions
and structural decay

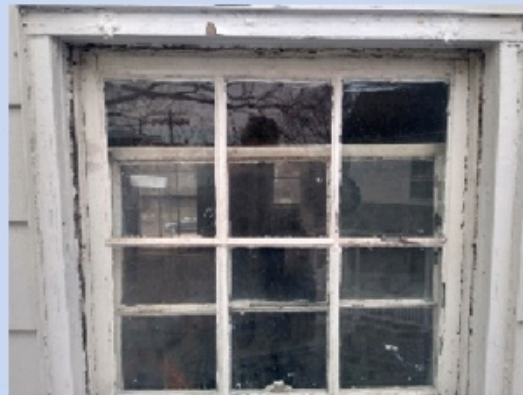
Overall weathering and
rot to sash and frame

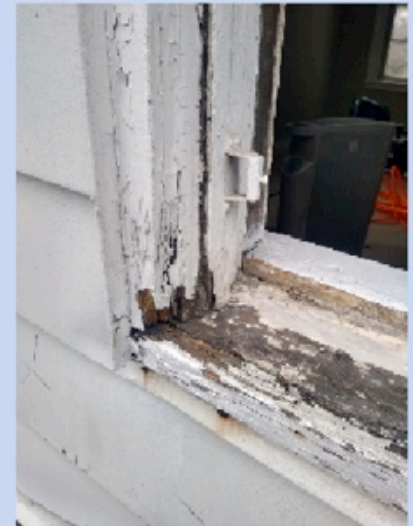
Rotted sill and casing

- Rot to the casings (pictured on previous page) and general degradation of the sash exteriors
- Disintegration to the mullions: 4 of the 6 sashes have exterior patches where there is no wood left to apply glazing putty
- Casing of window A has been “slumped” at least 1” out of square so there are unsealable gaps at the upper left and lower right corners
- Two of the sashes have mullions that have fallen out of alignment which is impossible to correct (pictured on previous page)
- Three sashes have sustained heavy damage (gouging/blowouts) to the edges, rails, and/or mullions.
