# Addendum 1

## Park Depot Bridge

BIN 092XXX Park Depot Bridge

over Woodland Depression

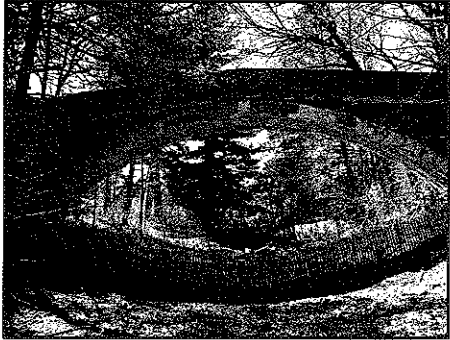
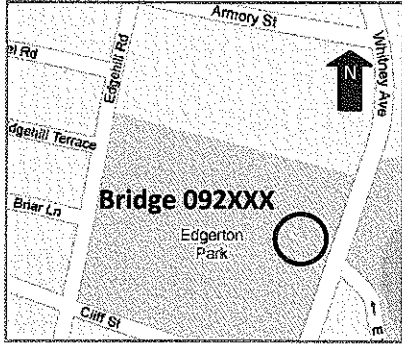
The timber deck bridge (approximately 10 foot wide) is supported by timber floor deck truss system and appears to be more recent in construction. There are no parapets or railings present on the bridge. The bridge approaches have been cordoned off from the dirt pathways by 8-foot high chain link fences to prevent entry onto the bridge. The bridge deck is supported by a 6-foot wide unreinforced concrete arch with an approximate span length of 65 feet. The fill between the deck and the arch is contained by stone masonry facing on both arch fascias. The arch intrados exhibits several random surface spalls, evidence of loose concrete and separation between grouted concrete type blocks. There are several areas with missing masonry facings on both the arch fascias.

The pier support walls at both ends of the arch exhibit random areas with missing concrete block facing. The U shaped wingwalls with stone masonry facing, which contain the roadway fill at both the approaches to bridge, appear to be in good condition. It is recommended that the 5' high timber picket fence present under the arch along both the fascias, to prevent people from walking under the bridge, be replaced with a taller fence system that is tied to the arch pier walls to completely cordon off the site underneath.

Since this bridge is not currently in service and does not carry any vehicular or pedestrian traffic, no safety inspections have been performed to our knowledge. If a safety inspection were to be performed today in accordance with the NBIS, the bridge would likely be classified in an overall "Poor" condition based on the condition of the concrete arch.

The once majestic looking bridge in its current “cordoned off” condition with potential for loose and falling concrete presents an eye sore in this beautiful historic park. It is recommended that a feasibility study be performed to investigate potential rehabilitation alternatives to reincorporate this bridge in the current park landscape. Since the current bridge deck appears to be more recent in construction, the focus of rehabilitation alternatives would essentially involve concrete repairs to the arch and addition of safe parapets and or pedestrian railings.
