## CITY OF NEW HAVEN BRIDGE INVENTORY

NOVEMBER 2008

# 1.0 Bridge Condition Assessment

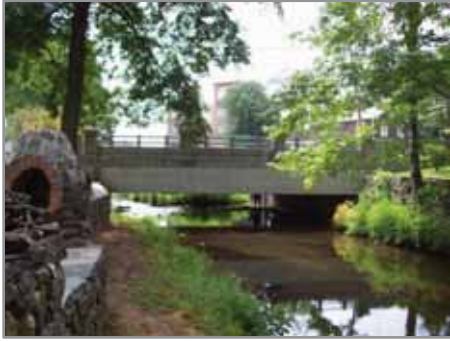
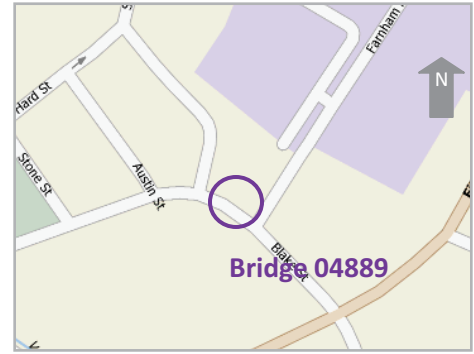
**BIN 04889 Blake Street**

- a. Inspection Agency: ConnDOT
- Inspection Frequency: 24 Months            Last Inspection Date: 07/02/07
- b. Component Condition Rating
- Deck: Very Good            Bridge Approach Condition: Very Good
- Superstructure: Very Good            Channel: Good
- Substructure: Good            Deck Geometry: Fair
- Culverts: NA            Under Clearance: NA
- c. Load Rating
- Bridge Rating: Not Available    Tons (INV)    Meets AASHTO Standards: Yes  No
- Basis of Rating: Calculations  Judgment     Is Bridge Posted: Yes  No

- a. Maintenance Recommendations (By DPW)
  - i) Tighten hanger anchor nuts and roller support nuts for the gas main located between Girders G11 & G12 (photo log 12).
  - ii) Install Bridge Identification Numbers on both parapets (2 EA).
  - iii) Fill the undermined portion below the SW & SE wingwall with grout and provide rip rap protection (photo log 14).

- i) Confirm with utility company if the gas main between Girders G11 & G12 require hanger supports in addition to the 3 provided (8 supports Required per Design Plans).
- ii) Confirm if the City is responsible for maintaining the stone masonry NW retaining wall (a 6' Wide x 8' High section has collapsed, photo log 19) & the SE retaining wall (a 20' Long portion of wall is leaning outward, photo log 9). Determine repair methodology, if necessary.
- iii) Determine the as-built load rating capacity of the bridge and update information.

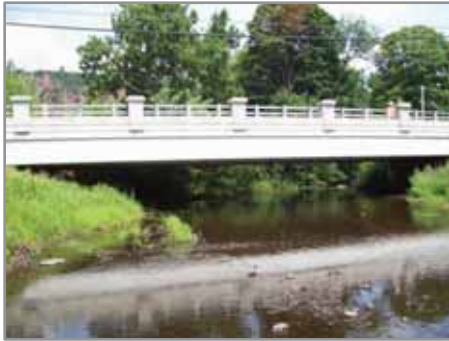
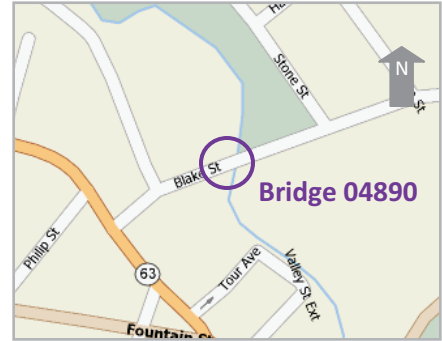
**BIN 04890 Blake Street**

Deck: Good            Bridge Approach Condition: Good

a. Maintenance Recommendations (By DPW) i) Install Bridge Identification Numbers on both parapets (2 EA).  
 Estimated Cost \$ 0.00

b. Short Term Repair Recommendations (By Contractor) i) Repair/reconstruct a 5' Long x 2' High section of SW wingwall with spalls and outward movement (photo log 21).  
 ii) Consider installing guiderails at all 4 approach corners to meet current safety standards (4 EA).  
 Estimated Cost \$ 20,000 (Item ii only, year 2009)

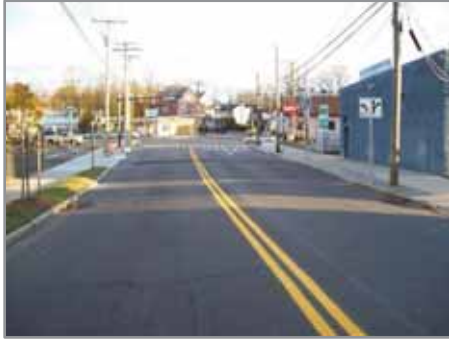
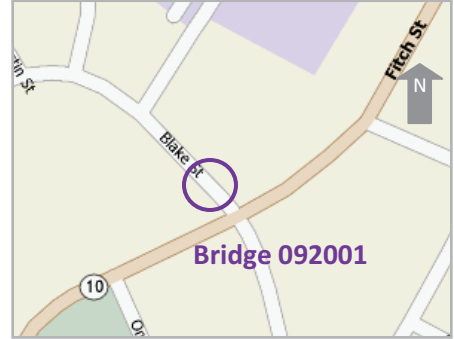
**BIN 092001 Blake Street**

Deck: NA              Bridge Approach Condition: Poor

- a. Maintenance Recommendations (By DPW)
  - i) Remove up to 12" of silt present in culvert (Reference 1991 ConnDOT Inspection).

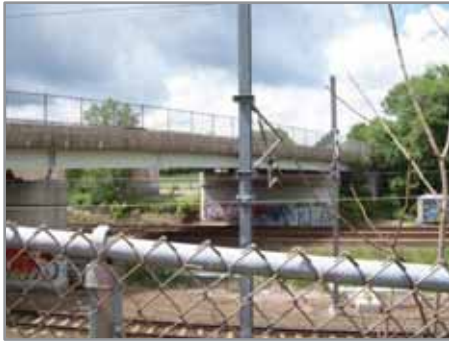
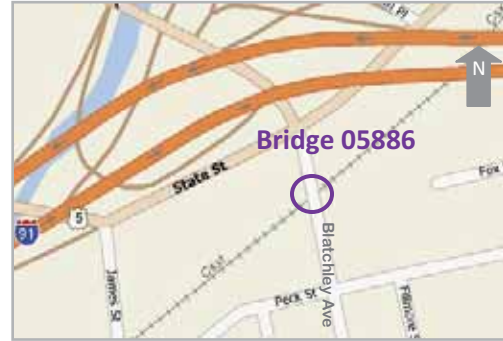
**BIN 05886 Blatchley Avenue**

Deck: Good              Bridge Approach Condition: Satisfactory

- i) This bridge was not inspected by ConnDOT in 2007 due to flagmen unavailability. It is anticipated that some of the deck condition ratings will be downgraded. Update condition information subsequent to ConnDOT inspection.

- a. Maintenance Recommendations (By DPW)
- i) Seal cracks in bituminous concrete pavement at bridge & patch potholes in pavement at approaches (photo log 13).
  - ii) Provide a bituminous ramp at settled north approach pavement in the vicinity of deck joint (2 Tons, photo log 18 & 19).
  - iii) Repair spalled concrete at both sidewalks in span 1 (<1 CY, photo log 24).
  - iv) Remove brush overgrowth & debris present on bridge & approach sidewalks (photo log 9 & 21).
  - v) Provide bituminous/concrete ramp at all 4 settled approach sidewalks to prevent tripping hazard (40 SF, photo log 22).
  - vi) Patch spalled concrete at west parapet in span 1 (<1 CY).
  - vii) Remove graffiti present on aluminum fence over railroad at east parapet (photo log 11).
  - viii) Install permanent Bridge Identification Numbers at both parapets (2 EA).
- Estimated Cost \$ 0.00

- b. Short Term Repair Recommendations (By Contractor)
- i) Replace damaged sections of chain link fence at west parapet in spans 2 & 3 and east parapet in span 2 (30 LF photo log 12, 17, & 23).
  - ii) Consider installing guide railing (MBR) at SE approach to protect vehicular traffic from blunt/exposed parapet end (1 EA, photo log 26).
  - iii) Replace the cracked MBR attachment to NW parapet (5 LF, photo log 20).
- Estimated Cost \$ 6,000.00 (Year 2009)

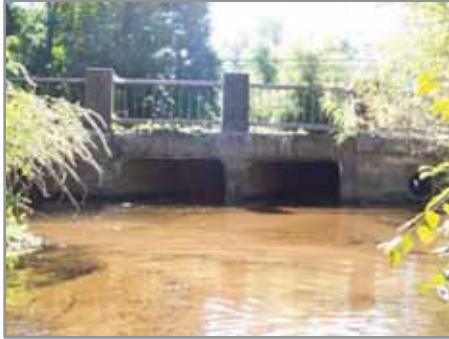
**BIN 092002 Brookside Avenue**

Deck: NA Bridge Approach Condition: Poor\*  
Superstructure: NA Channel: Fair\*  
Substructure: NA Deck Geometry: Excellent\*  
Culverts: Fair\* Under Clearance: NA

- a. Maintenance Recommendations (By DPW)
  - i) Patch delaminated and punky concrete present on headwall, wingwall & barrel (10 CY, photo log 1 – 11).
  - ii) Mill and repave the deteriorated/settled bituminous concrete pavement over the culvert & the approaches (450 SY, photo log 16 and 17).
  - ii) Trim vegetation encroaching over the railing and fence at NE corner (photo log 22).
  - iii) Clean clogged CB grates (3 EA, photo log 14).
  - iv) Grout the hole at the steel rail attachment to concrete pylon (4 EA, photo log 19).
  - v) Remove leaf & dirt debris present on south sidewalk.  
Estimated Cost \$ 0.00

- b. Short Term Repair Recommendations (By Contractor)
  - i) Consider installing MBR at approaches to meet current standards (4 EA).  
Estimated Cost \$ 20,000 (Year 2009)

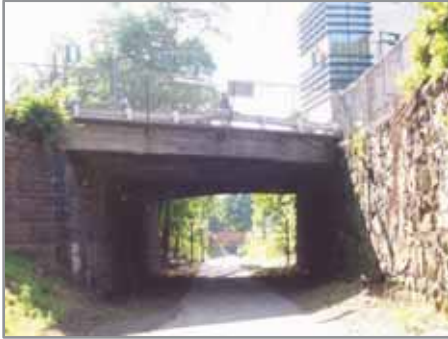
**BIN 03997 Prospect Street**

i) The bridge is in poor condition and is being inspected by ConnDOT annually. The bridge replacement is scheduled to begin in spring 2009. Every effort must be made to keep the schedule.
