**City Of New Haven
New Haven, CT**

(Final - Energy Audit Report)

**Energy Management and Conservation
Project**

Stimulus- # 28-04-651

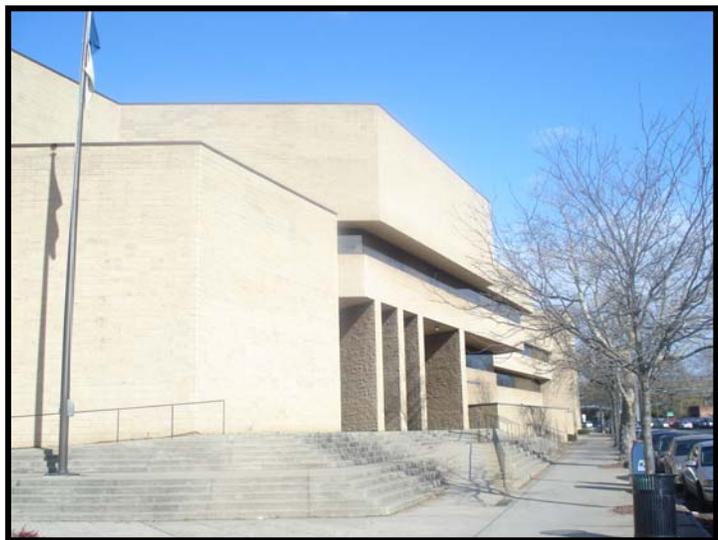
The Police Headquarters located at 1 Union Ave is classified as an administrative and office facility. This four story structure was built in 1975 and has 105,000 square feet of conditioned space. Recent renovations include a \$4 million dollar HVAC retrofit, and the installation of two (2) new boilers. The key areas of survey include six (6) large Air Handling Units, two (2) closed loop cooling towers, and a 25 kW backup generator. It was observed that occupancy sensors had recently been installed in selected hallways, office areas.

The exterior lighting, attached to the exterior wall, consisted of Metal Halide HID wall packs. Dual incandescent, metal halide, recessed ceiling fixtures were present in the parking garage. Also observed in the front entrance foyer were recessed incandescent ceiling fixtures.

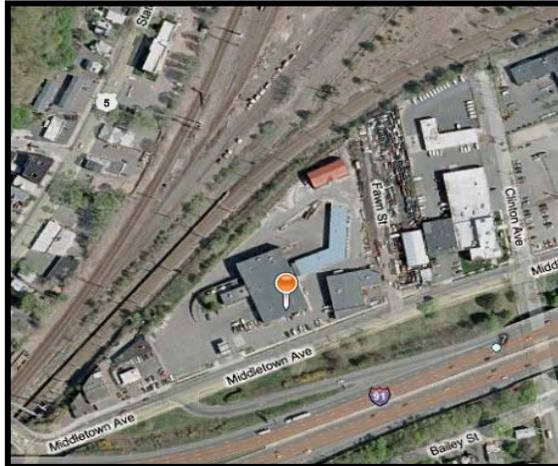
The Public Works building located at 34 Middletown Ave is classified as a vehicle repair garage and administrative office space. This 2 story structure was built in 1950 and has approximately 91,000 square feet. Additions were made in 2002 which includes the street light administration and vehicle storage departments.

The key areas that were surveyed targeted the main repair garage, boilers, and office roof top units. Three way control valves located in the street light admin building and lower storage areas were documented.

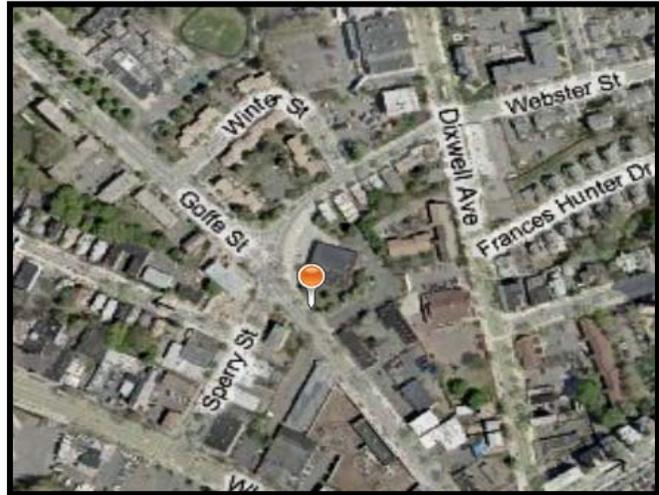
The areas of focus in this survey were the five (5) gas-fired DX Roof Top Units. These units have an output of 95,000 BTUs with an efficiency rating of 80%. It was observed that they did not have economizer controls for the outdoor air damper.

A 98 gallon, gas fired, hot water heater supplies the domestic hot water to the facility.

Interior lighting consists of 2x4, T-12 magnetic ballast, fluorescent lamps and fixtures. It was observed that the interior lighting including the exit signs were beyond useful life. Also, there were a minimum of 3 vending machines in the living area that operate 24/7.

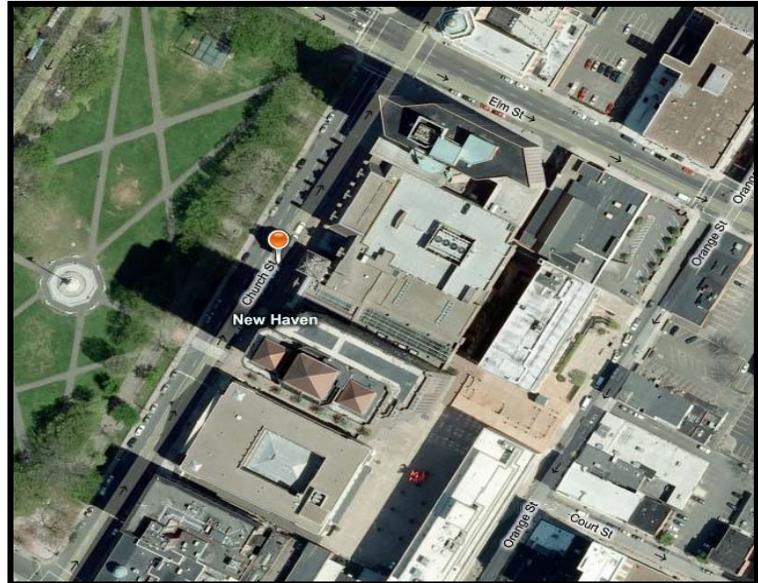
City Hall is located at 165 Chapel St and has 120,000 square feet of tempered space. This six story structure was built in 1930 and is classified as administrative and office space. The weekday hours of operation are typical 9 to 5. The main areas surveyed were the six (6) large AHUs and the Runtell Radiation units. It was observed that the heating and cooling was provided by a 4-pipe system fed from the Central Plant. Each AHU has its own Glycol loop.

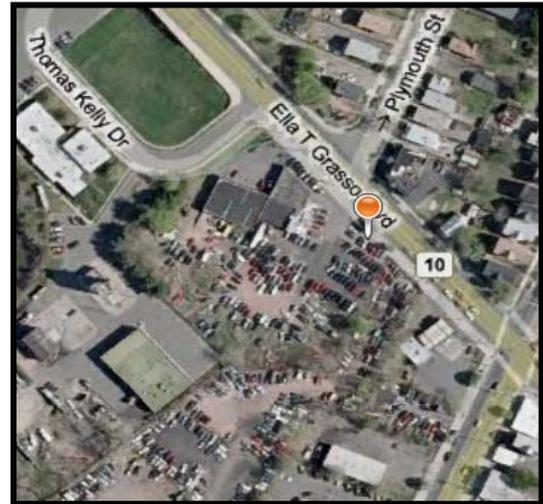
The fire training facility is located at 230 Ella Grasso Blvd. The (2) story building has 3,400 square feet of tempered space, and is classified as classroom and administrative offices. In addition to the main building, a 2-story vehicle storage and repair facility supports the training operation. The key areas surveyed include the three (3) DX Roof Top Units on the main building, and the (2) two air handling units in the vehicle maintenance garage. It was observed that a Reznor Package Air Handler was installed in 1995 to supplement the existing heating and cooling system.

Other systems and equipment surveyed include a recently installed Burnahm boiler, and an 85 gallon electric, domestic hot water tank heater. The primary source of heat in the vehicle maintenance area is infrared tube heating. A 125 kW diesel generator provides standby power in the event of utility power loss. All of the interior lighting has been converted to T-8 electronic ballast fixtures.

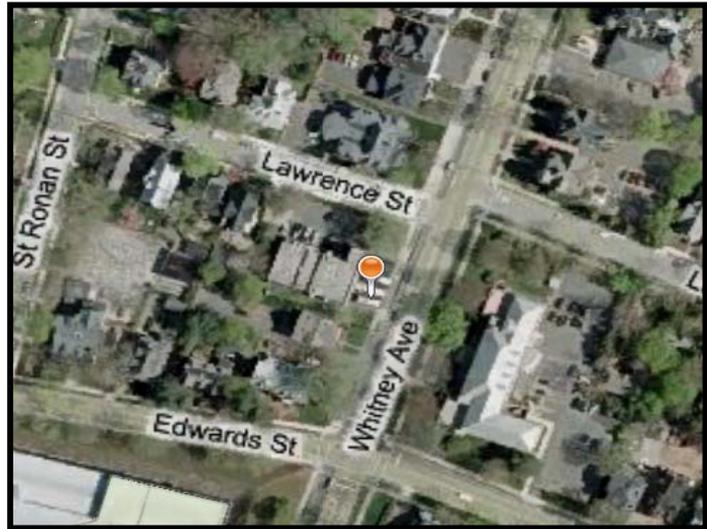
The areas of focus included a gas fired hot water circulating boiler installed in 1995. A gas fired domestic hot water heater with a capacity of 78 gallons, was found to be in poor condition and leaking.

Interior lighting consists of 2x4, T-8 electronic ballast fixtures and lamps. It was observed that the skylights in the truck bay did not have any lumen sensing. Lights around the perimeter of the building were observed to be on during daylight hours. The exit signs are incandescent fixtures and are beyond useful life.

The truck bay has infrared tube heaters. Multiple forced hot water unit heaters in truck bays were found to be out of service. Radial thermostats in the living spaces control the temperature to specific zones.

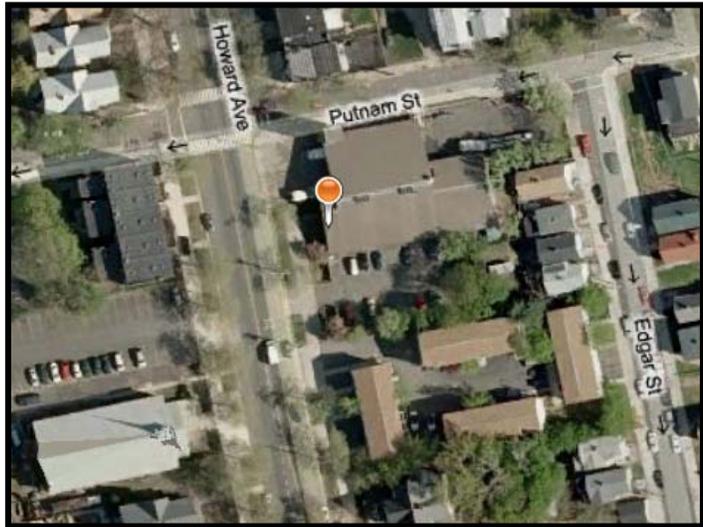
The main areas of focus include the gas-fired, 1,100,000 BTU, hot water circulating boiler, a 10 Ton condensing unit, and a Air Handling Unit with outdoor air and hot water reheat. Additional heating is provided through perimeter electric radiation in the barrack spaces.

Domestic hot water is provided by a gas fired, 75 gallon unit.

Multiple infrared tube heaters provide space heating in the truck bays. It was observed in the truck bays that the lighting was T-12 magnetic ballasted fixtures in need of replacement. Exterior lighting consists of antiquated High Pressure Sodium fixtures and lamps. There were multiple vending machines in the barrack spaces.

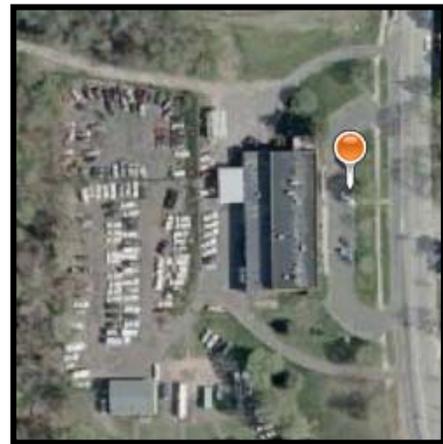
The main areas of focus include gas fired unit heaters, in the repair bay, one new Moncton, 199,000 BTU, condensing hot water boiler, and a new gas fired, 85 gallon, domestic hot water tank. It was observed that (5) five new Trane Roof Top Units with gas heat and economizer controls, serve the second floor administrative offices.

The interior lighting consists mainly of new 2x4, T-8 electronic ballast fixtures and lamps. There were some scattered T-12 magnetic ballasted fixtures located in the garage space.

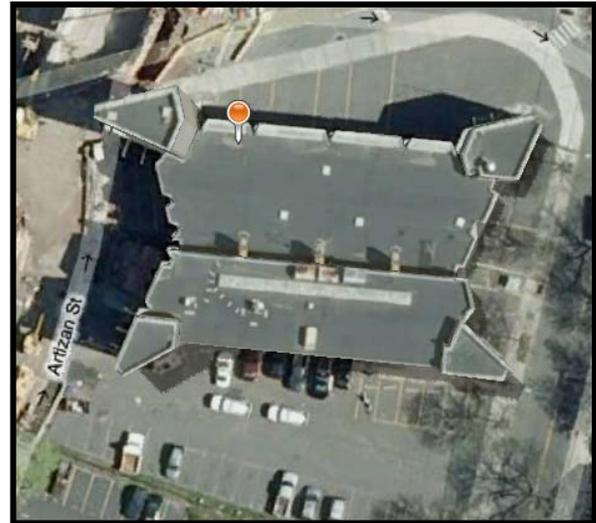
The areas of focus at this facility include the heating and cooling equipment throughout the building. It was observed that the water source heat pumps located on the roof, were in an extremely poor condition. The cooling tower circulating pumps and the boiler were operating with no apparent switchover controls. (2) Two gas boilers with 1,240,000 BTU output were observed to be approaching the end of their useful life. A 90 gallon, gas fired domestic hot water heater had an additional booster circulation pump with a return sensor to provide hot water to the barracks and the pressure washer.

It was also observed that the hot water loop reset controller and bypass valve re-circulators are very old and likely out of service. The forced hot water piping is un-insulated. Various fan coil units on the second floor are hot water heating only. The outside air ducts had closed dampers. Newly installed infrared tube heaters were located in the high bay truck garage.

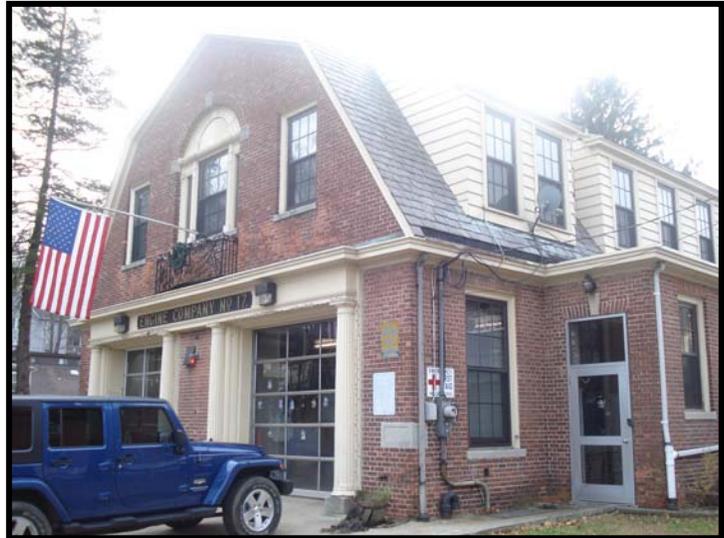
The East Grand Fire House located on East Grand Ave has 4,100 square feet of space and is designated as vehicle storage and livable quarters. An atmospheric steam boiler with an output of 440,000 BTUs is in poor condition and beyond useful life. A gas fired domestic hot water heater was just recently installed. The building has a single zone thermostat that controls the steam supply to conventional steam radiators throughout the building.

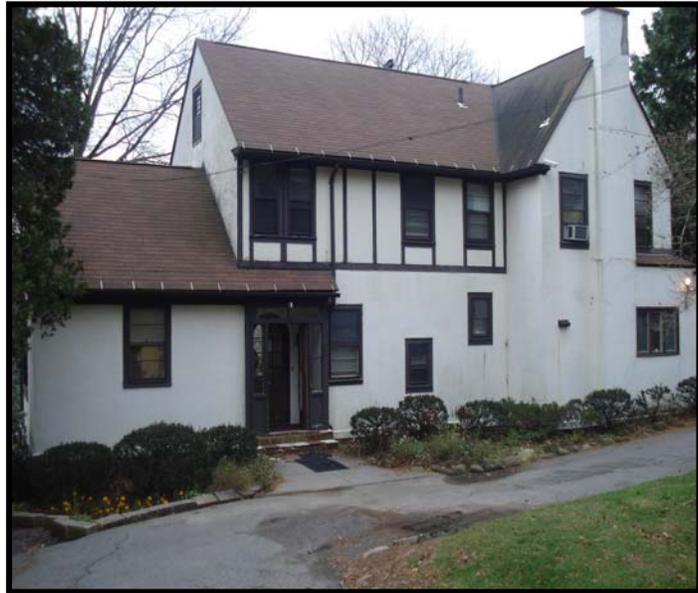
The garage and repair buildings in close proximity are old and in need of immediate repair. The forced air furnaces are beyond useful life.

Lighting in the garages are T-12 fixtures that are also beyond useful life.

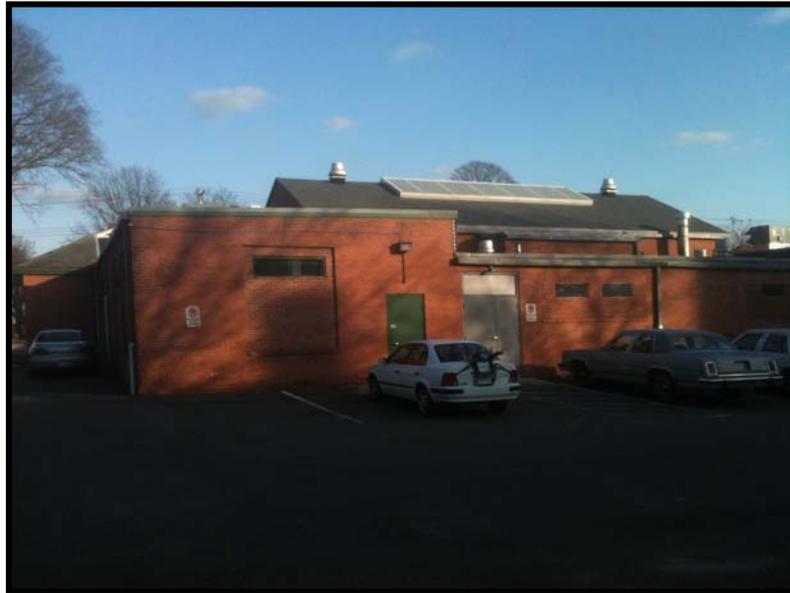
The key areas of interest suggested by the New Haven personnel were the rooftop units and the 1.2 mil BTU condenser boiler. The heating and cooling is provided by a common 2-pipe system.

A 50 gallon gas fired hot water heater provides domestic water to the lavatories.

The interior lighting has a mix of T-8 EB and T-12 MB, 2x4 Fluorescent fixtures. Exterior lighting is provided by a minimal amount of HID fixtures.

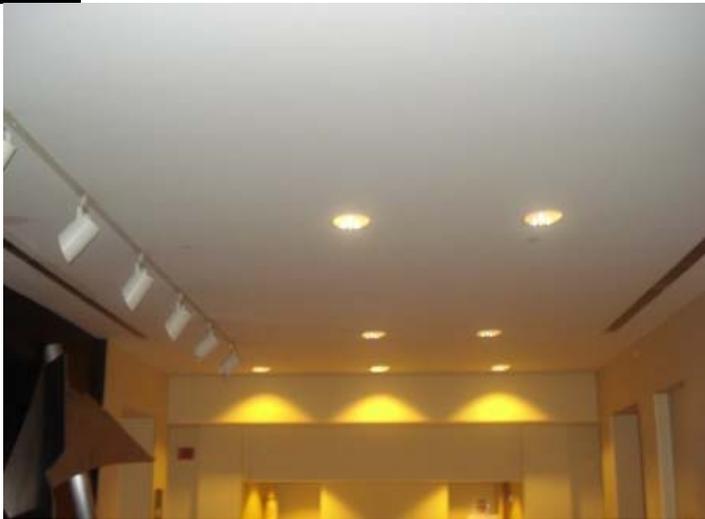
It was observed that there were very limited lighting controls in the various buildings surveyed. Exterior lighting did not have lumen sensing. Occupancy sensors were installed in a limited amount of spaces.

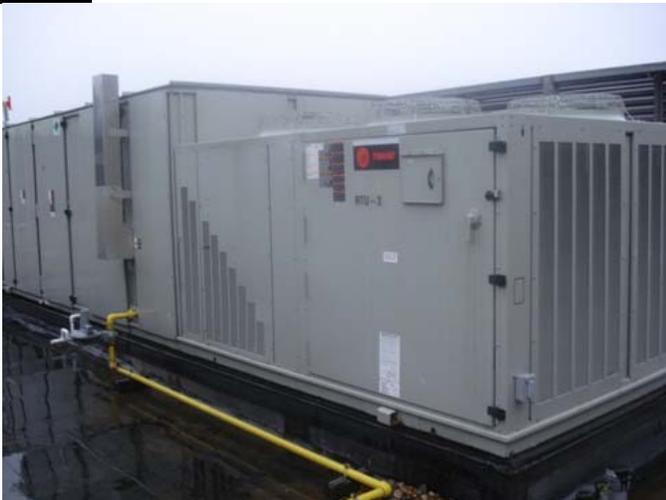
It was observed that current configuration has supply fans maintaining continuous static pressure and OA dampers in non-gradient incremental positions which in turn created unnecessary reheat of OA that increased energy consumption. The areas of main concern were Elm St, Wilson, Stetson, and Grand Library

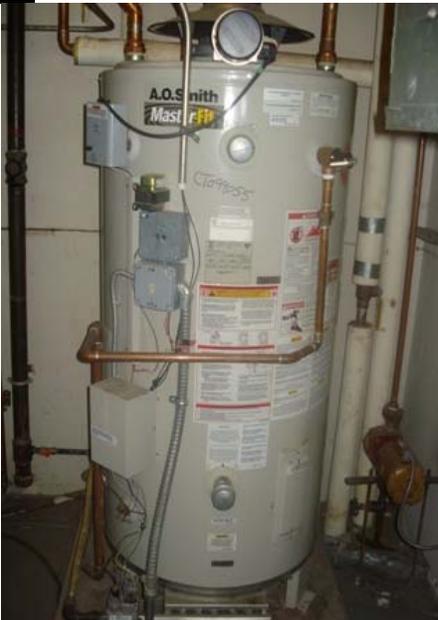
It was observed that current configuration of the domestic hot water provides low temperature supply and crossover to the coldwater supply. It was found that the current system is oversized for a Library Application.

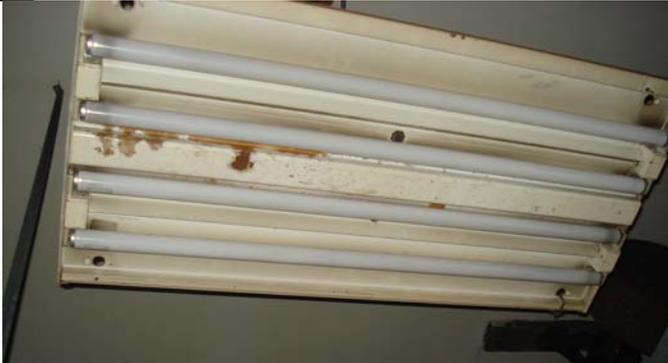
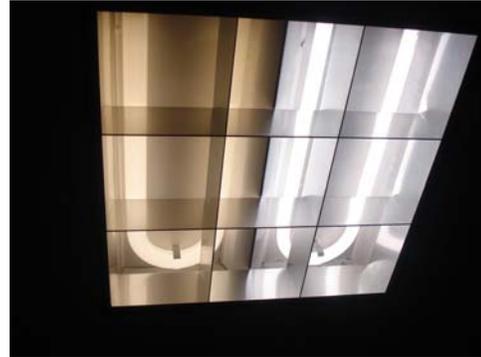
It was observed that multiple buildings still had T-12 and older technological lights in place. These lights are usually either in basement and mechanical spaces or in truck bays.

Replace all T-12 lights with newer, more efficient T-8 lights.

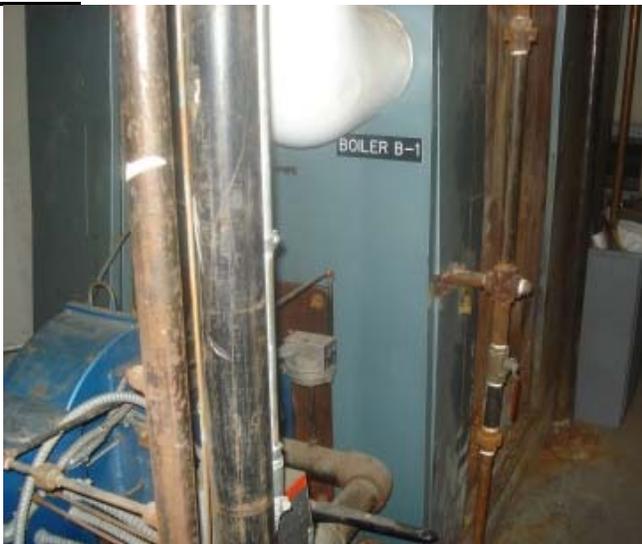
It was observed in thirteen (13) locations that the current boiler operation is programmed to maintain space temperature without any consideration of outside air temperature. There was significant heat loss in the hot water/steam loops and therefore minimized the return condensate/steam loop to drive down efficiency.

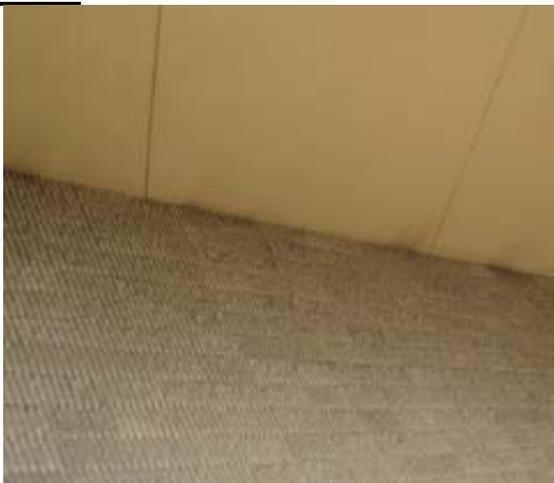
It was observed in several locations of external building shell gaps that allowed the escape of cool and hot air from the interior occupied spaces. It was also observed in various locations of thermal and cooling air leakage through window casements and exterior doors.

Police HDQTRS, front entrance, front wall and exterior ceiling visual dust residue from air draft velocity from interior.

Conduct infrared and thermal analysis to include below 40 degree and above 80 degree day analysis. HVAC controls should be modified to initiate a positive air pressure and negative air pressure conditions. Conduct a low cost weatherization based on findings.

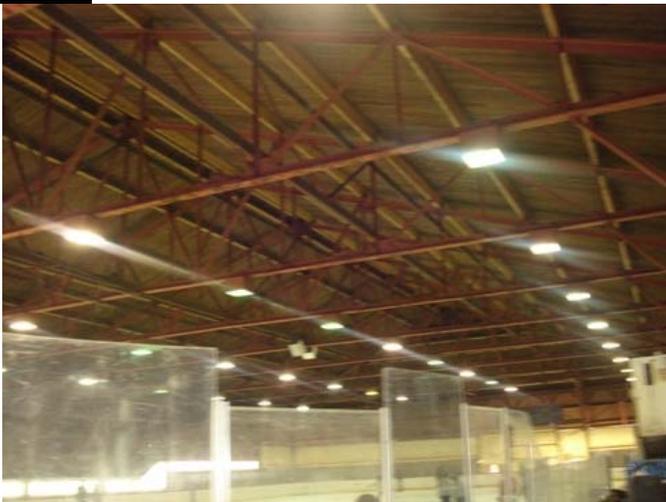
It was observed in the Police Head quarters lower parking area and the Ice Rink that the lighting levels were found to be excessive and in-efficient. The lower parking area has eighty (80) recessed fixtures that contain two (2) 150 w metal halide lamps. The Ice Rink was observed to have thirty-six (36) 1500w metal halide fixtures. Both of these locations require a lighting upgrade to energy efficient lighting.

Replace (36) Metal Halide 1500 W fixtures and lamps in the Ice Rink and (80) 300w incandescent recessed lights in the Police Headquarters Lower parking Garage with (40) in the Ice rink, (20) in the lower parking garage, all 4x4, T5 fluorescent fixtures, complete with (4) 54 W lamps, conical- shaped reflective down lenses, and low amp energy efficient electronic ballasts. The reflectance factor will be set at 80% floor, 40% wall, and 5% ceiling. This will increase pupil lumens from 50 to 85.

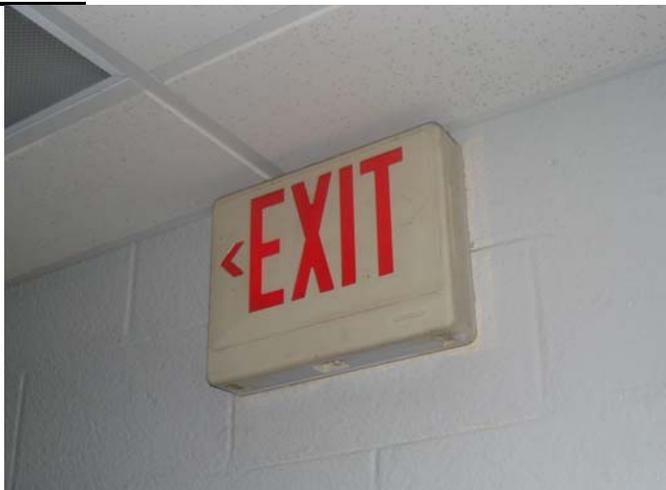
It was observed that all Exit Signs, throughout most buildings, use old incandescent bulb technologies. It is estimated that there are around 230 Exit Signs in all the buildings. These require around 30 W of power each for normal operation. They also operate 24/7, so they are on for 8,760 hours of the year.

Replace all incandescent Exit Signs within all buildings with low cost, newer LED based Exit Signs. These would decrease power usage for each Exit Sign from 30 W to 4 W.

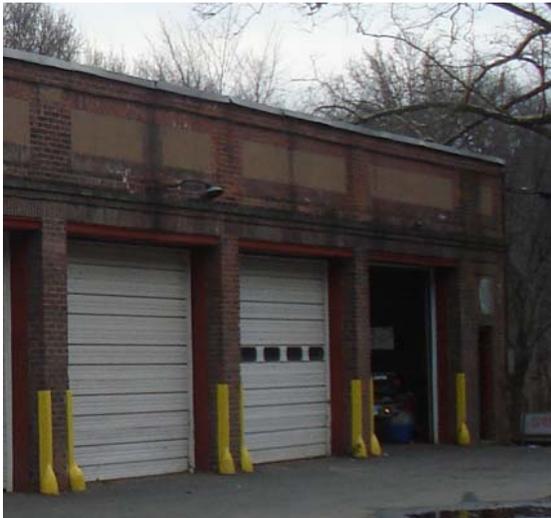
Multiple facilities with large doors like fire stations and repair facilities currently have no means to prevent excessive heating if a door is left open. It was observed at a few sites that the heat was running in order to counterbalance the outside air coming through the open doors.

Introduce an interlock that cuts off the heat if doors are left open. This would provide an incentive for the occupants to keep the door closed. Additional safety measures would need to be put in place to prevent damage that could be caused by extremely low temperatures. This ECM would apply to all fire stations, the police repair facility and the parks and recreation garages.

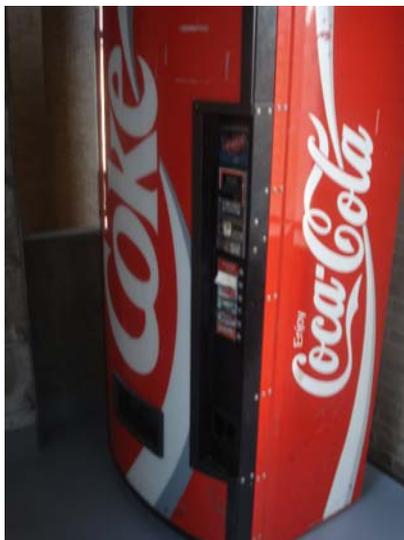
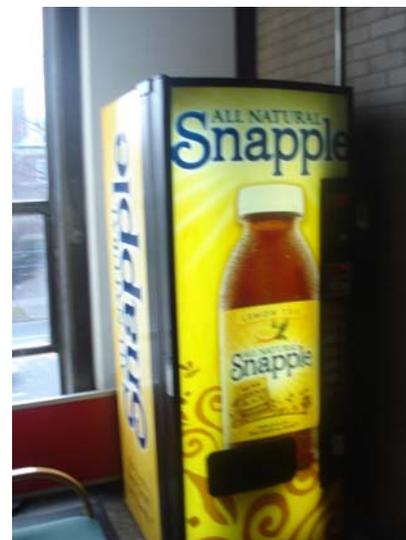
It was observed that there were multiple cold drink vending machines located throughout the buildings. There is a potential for energy cost savings by reducing the running time and the off-hour usage of these machines using Vending Miser

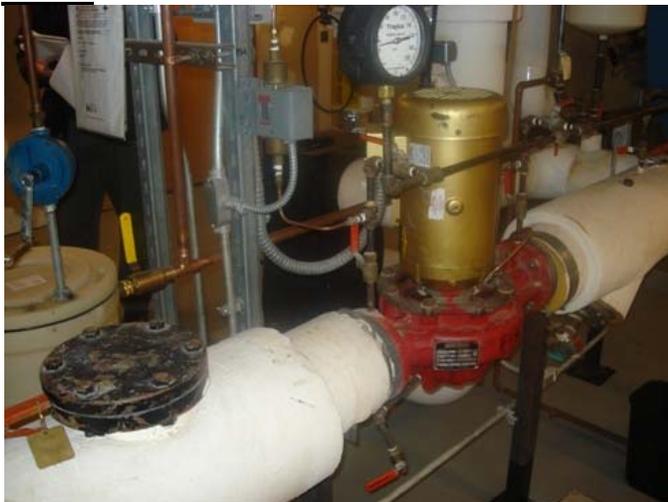
Photos

It was observed that the hot water and cold water circulating pumps ran at a constant volume. The 4-pipe system was found to be inefficient especially during the shoulder months. The glycol loop was found to have a constant volume condition.

Install VFD's on the hot water circulating pumps and glycol loop

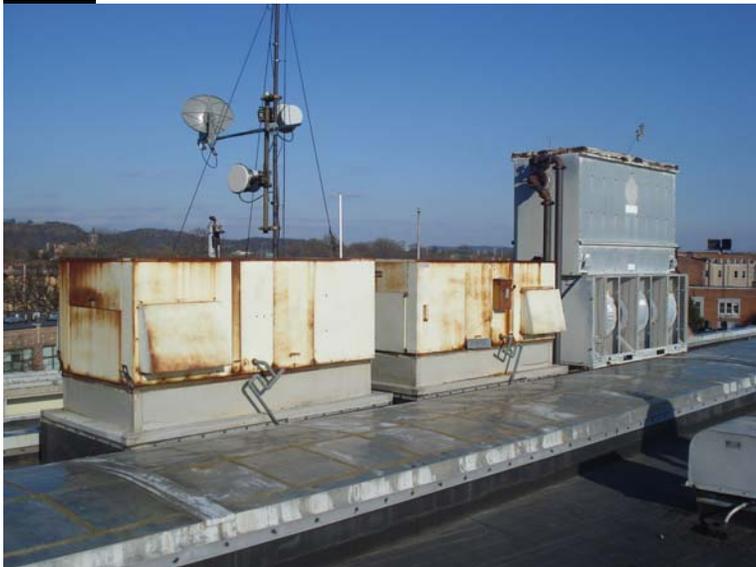
Photos

It was observed that the heat pump and the cooling tower at the Fire Headquarters were well beyond useful life. The 4-pipe system was found to be inefficient especially when both heating and cooling equipment were operating simultaneously.

Install new equipment on both the hot water and cooling tower circulating pumps. Install DDC controls on equipment to both monitor and operate flows in an efficient manner.

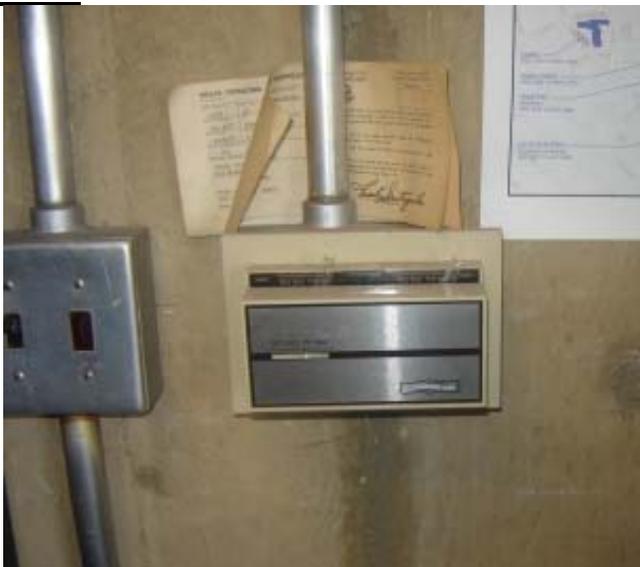
Photos

It was observed that all buildings surveyed were experiencing control problems and the absence of a central DDS with a reporting feature to notify personnel of corrections. Lack of re-commissioning vital equipment contributes to excessive energy usage.

Install a BACnet DDC controller panels with monitoring points for space temperature and all inclusive control points for all facilities. Sensor plates and wiring for all space enclosures associated with the HVAC systems are included. Alarm monitoring also included. Combine existing DDS controls on equipment that both monitors and operates existing systems. This includes the boiler control ECM.

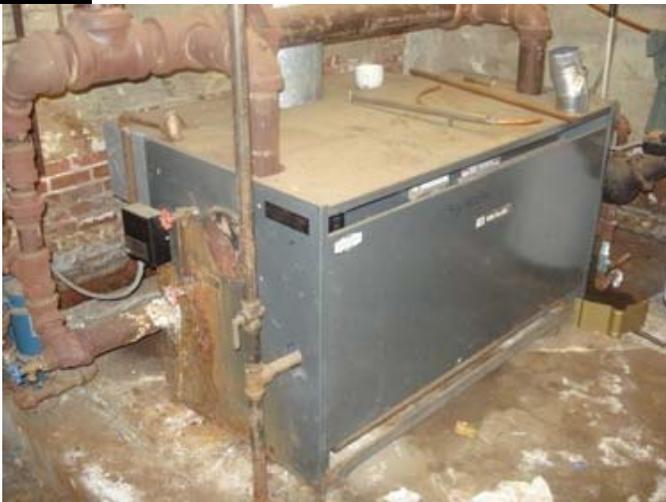
Photos

It was observed that the boiler in the East Grand Fire Station was found to be in poor condition. It was found to have a steam to hot water heat exchanger that further reduces efficiency.

Replace boiler with an industrial energy star AFUE 90% rated 500000 BTU package boiler. Install BAS controls and additional thermostats on Outside air monitoring and Demand response controls. Install additional temperature sensing on the hot water supply loop. Install DDC control points to measure temp and enthalpy. Existing sensors and points should be utilized.

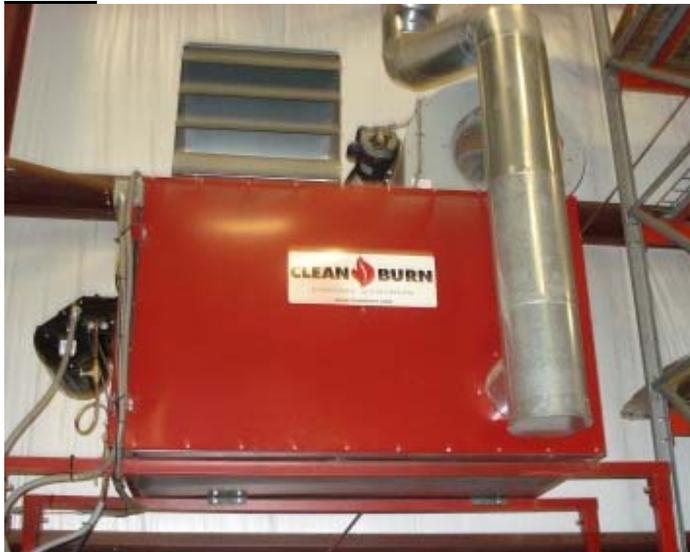
Photos

It was observed that the Public Works Garage had waste oil storage on site. The combination of steam and electric unit heaters heating the space were beyond useful life. Utilizing the waste oil would reduce energy expenditures by about 80%

Replace steam and electric unit heaters with “Clean Burn Waste oil boilers with an industrial energy star AFUE 90% rated 250000 BTU. Install BAS controls and additional thermostats on Outside air monitoring and CO monitoring. Install additional sensing on the exhaust fans control sequencing. Install DDC control points to measure temp, CO, and enthalpy. Existing sensors and points should be utilized.

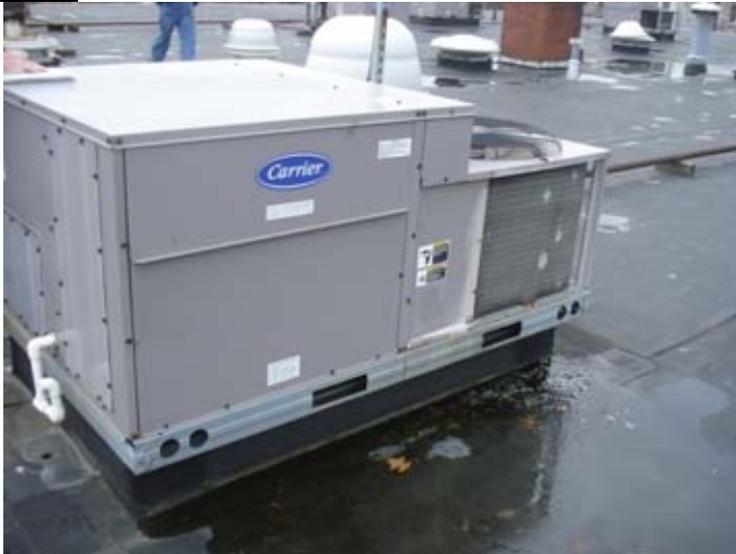
Photos

It was observed that the (5) existing package rooftop units that feed the fire station are beyond useful life. It was observed the frames had corrosion and the coils were found to be in poor condition.

Replace all (5) roof top units with Seer 15.5, high efficient, 100,000 BTU DX package units. Install DDC controller with termination points for BAS control. Install additional ductwork to accommodate cross duct arrangement to limit operation and to allow for maintenance. New unit to have ASHRAE 90.1-2010 minimum standard Install DCV controls in the BAS.

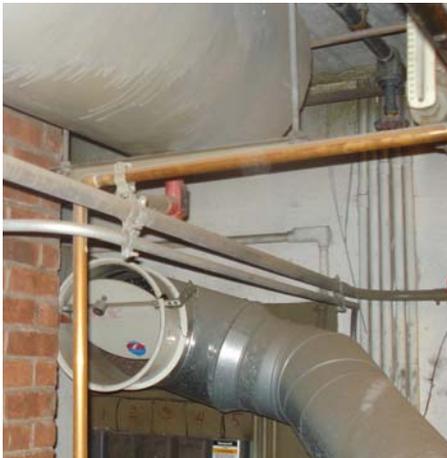
Photos

It was observed that most heating pipes in smaller size facilities were not insulated. This problem leads to excessive radiant heat loss and increased energy cost.

Install insulation around all thermal pipes in order to prevent heat loss and lower energy costs. This ECM applies to the Lombard Fire House, East Grand Ave Fire House, Woodward Fire House, Ellsworth Fire House, Grand Ave Library and the Fire Headquarters. Insulated pipes typically increase the temperature of water within by 2-4 degrees F.

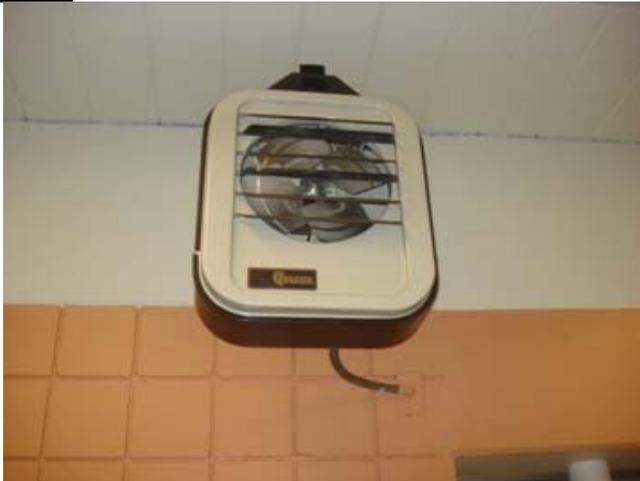
Photos

The Park and Rec facility is heated by (6) Electric Unit Heaters mounted on the ceiling and wall. These heaters are 15 kW units. Some of these units appear to have coil degradation which increases energy use by a factor of 1.5. The total electric draw is 90 kW at 480 volts. Each of these unit heaters is on an individual thermostat. In operation they are turned on in the fall and left in operation until the spring.

Install (6) gas fired unit heaters in place of the existing electric unit heaters. Piping of low pressure gas will be required from service entry meter. Install temperature sensor plates with auto shutoff controls.

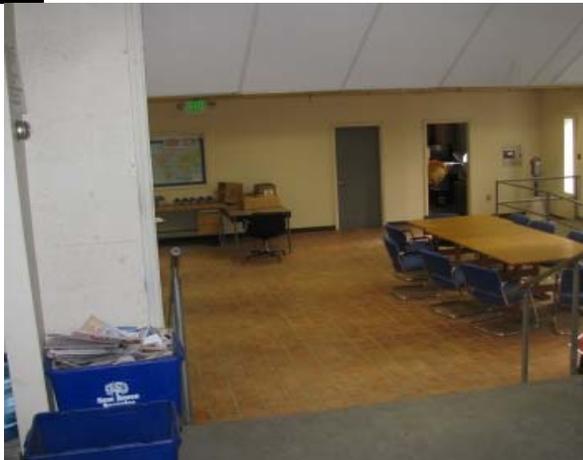
Bi-level office at 42 Middletown is heated and cooled with (2) separate systems yet open floor plan.
