## CITY OF NEW HAVEN BRIDGE INVENTORY

NOVEMBER 2008

# 1.0 Bridge Condition Assessment

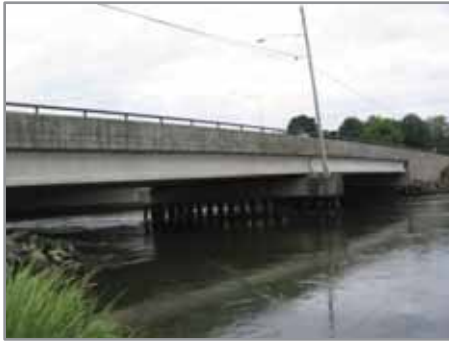
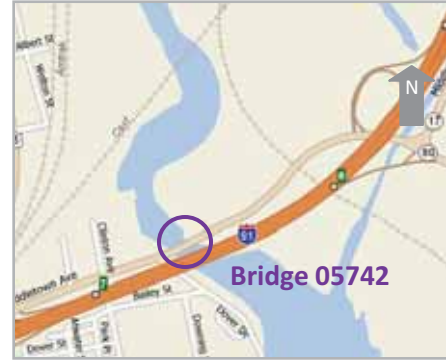
## BIN 05742 Middletown Avenue

- a. Inspection Agency: ConnDOT
- Inspection Frequency: 24 Months            Last Inspection Date: 05/01/07
- b. Component Condition Rating
- Deck: Good            Bridge Approach Condition: Satisfactory
- Superstructure: Good            Channel: Fair
- Substructure: Good            Deck Geometry: Excellent
- Culverts: NA            Under Clearance: NA
- c. Load Rating
- Bridge Rating: 66.7            Tons (INV)    Meets AASHTO Standards: Yes  No
- Basis of Rating: Calculations  Judgment     Is Bridge Posted: Yes  No

- i) Continue monitoring the cracks present at the pier ends of prestressed concrete beams.
- ii) Continue monitoring the channel scour conditions. The underwater inspections have been noting moderate to extensive changes to channel bottom elevations.

- a. Maintenance Recommendations (By DPW)
- i) Seal cracks and patch potholes in bituminous concrete pavement at bridge and approaches (250 LF, photo log 8 & 9).

- iv) Remove and reconstruct the settled/cracked area of SW approach sidewalk (20 SF, photo log 4).
  - v) Provide weep pipe extensions below girder bottom flange to prevent water draining onto prestressed concrete beams (18 EA).

- vi) Tighten 2 of 4 loose anchor bolt nuts at utility pole mounted on pier at west end (2 EA, photo log 25).
  - vii) Install Bridge Identification Number on both parapets (2EA).

- viii) Install missing nuts at SW MBR attachment to concrete end block/foundation (4 EA, photo log 2).
- Estimated Cost \$ 0.00

- b. Short Term Repair Recommendations (By Contractor)
- Reconstruct the cracked/deteriorated saw & seal deck joint at both
  - i) abutments (96 LF, photo log 7 & 12).
- Estimated Cost \$2,500 (Year2009)

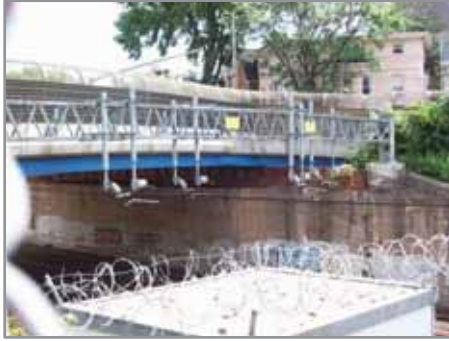
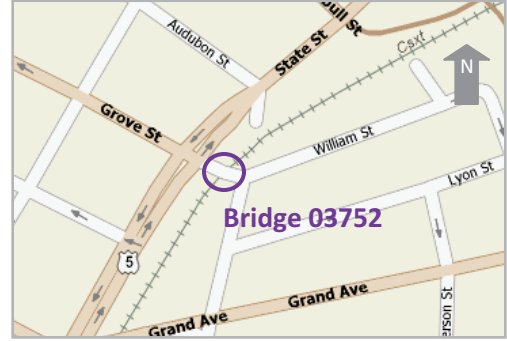
**BIN 03752 Olive Street**

- a. Inspection Agency: ConnDOT
- Inspection Frequency: 24 Months Last Inspection Date: 06/09/05
- b. Component Condition Rating
- Deck: Very Good Bridge Approach Condition: Very Good
- Superstructure: Good Channel: NA
- Substructure: Good Deck Geometry: Critical
- Culverts: NA Under Clearance: Severe
- c. Load Rating
- Bridge Rating: 66.9 Tons (INV) Meets AASHTO Standards: Yes  No
- Basis of Rating: Calculations  Judgment  Is Bridge Posted: Yes  No

- a. Maintenance Recommendations (By DPW)
- i) Seal cracks in bituminous concrete pavement at west approach to the bridge (80 LF, photo log 1).
  - ii) Provide a patch for spalled and settled concrete at NW approach sidewalk (1 CY, photo log 6).
  - iii) Provide a bituminous/concrete ramp to eliminate tripping hazard at settled NE & SE approach sidewalks (20 SF, photo log 12).
  - iv) Remove light graffiti present on rail panels & parapets (75 SF, photo log 17).
  - v) Replace missing hand hole cover at light pole which has resulted in exposed wires (1EA, photo log 18).
  - vi) Tighten loose timber rubrail attachment to 3<sup>rd</sup> post from bridge at SW MBR (1 EA).
  - vii) Install Bridge Identification Number on both parapets (2 EA).

- b. Short Term Repair Recommendations (By Contractor)
- i) Replace the asphaltic plug deck joint at east abutment (44 LF, photo log 11).
  - ii) Replace impact damaged (minor) portion of SW MBR (20 LF, photo log 14).
  - iii) Replace the SE MBR and attach it to parapet to prevent a gap and eliminate a traffic safety hazard (25 LF, photo log 13).

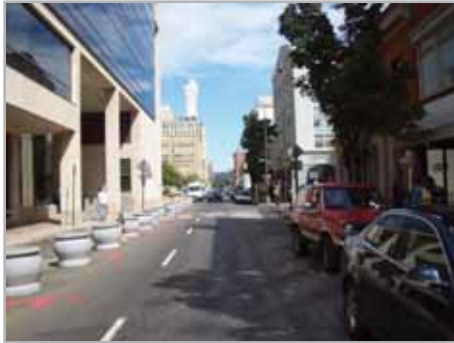
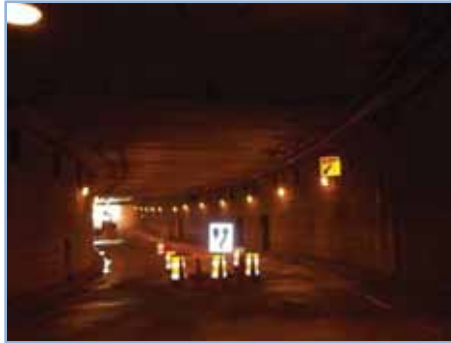
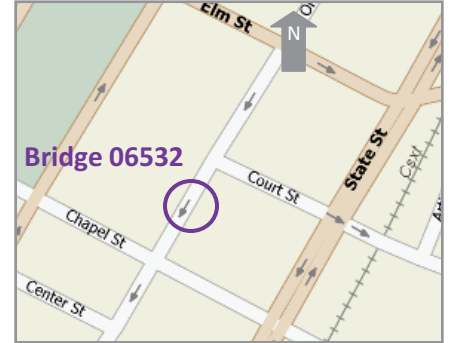
## BIN 06532 Orange Street over Government Center Access Road

- a. Inspection Agency: ConnDOT
- Inspection Frequency: 24 Months            Last Inspection Date: 08/08/07
- b. Component Condition Rating
- Deck: Satisfactory            Bridge Approach Condition: Satisfactory
- Superstructure: Satisfactory            Channel: NA
- Substructure: Good            Deck Geometry: Good
- Culverts: NA            Under Clearance: Poor
- c. Load Rating
- Bridge Rating: 34.0            Tons (INV)            Meets AASHTO Standards: Yes  No
- Basis of Rating: Calculations  Judgment             Is Bridge Posted: Yes  No

- i) Repair the depressed areas and potholes in the bituminous concrete pavement at intersection of Court Street and Orange Street (1 TON, photo log 5 & 6).
  - ii) Patch spalled and hollow sounding concrete in the underside of concrete slab (2 CY, photo log 1 and 10).
  - iii) Seal the joint at the west end of slab to prevent water leakage which results in deterioration to the concrete slab.
  - iv) Install Bridge Identification Number at abutments since it is difficult to identify the bridge in the tunnel (2 EA).
- Estimated Cost \$ 0.00

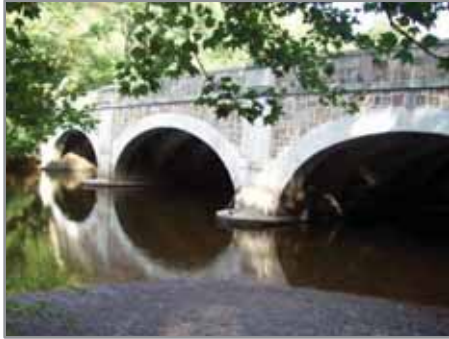
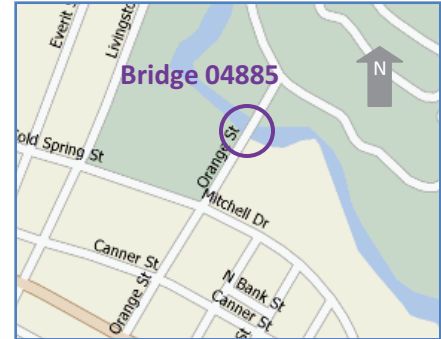
**BIN 04885 Orange Street #1**

- a. Inspection Agency: ConnDOT
- Inspection Frequency: 24 Months      Last Inspection Date: 07/20/07
- b. Component Condition Rating
- Deck: Good      Bridge Approach Condition: Good
- Superstructure: Satisfactory      Channel: Good
- Substructure: Good      Deck Geometry: Fair
- Culverts: NA      Under Clearance: NA
- c. Load Rating
- Bridge Rating: 34.0      Tons (INV)      Meets AASHTO Standards: Yes  No
- Basis of Rating: Calculations  Judgment       Is Bridge Posted: Yes  No

- i) Perform a load rating capacity of bridge and update current information which is based on judgment. This may improve overall bridge rating.
- ii) The need for permits and containment to perform repairs over Watercourse will need to be determined.

- a. Maintenance Recommendations (By DPW)
- i) Provide bituminous/concrete ramp at settled NW, NE & SE approach sidewalks to prevent tripping hazard (30 SF, photo log 3).
  - ii) Install extension to weep pipe below arch ribs to prevent water draining onto superstructure (24 EA, photo log 24).
  - iii) Install bridge identification number on both parapets (2 EA).
  - iv) Patch spalled concrete on west parapet at south end (<1 CY, photo log 14).
- Estimated Cost \$ 0.00

- b. Short Term Repair Recommendations (By Contractor)
- i) Install a saw & seal deck joint at both abutments to prevent pavement cracking (68 LF, photo log 4).
  - ii) Patch delaminated and hollow sounding areas of arch ribs (2 CY, photo log 21, 22, 26).
  - iii) Seal open cracks in arch ribs by injecting epoxy (110 LF).
  - iv) Patch delaminated & scaled areas in abutment stems & pier (0.5 CY).
- Estimated Cost \$ 90,000 (Year 2009)

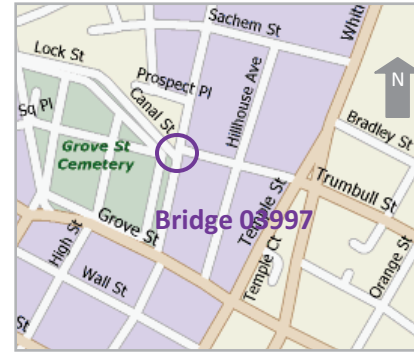
**BIN 03997 Prospect Street**

i) The bridge is in poor condition and is being inspected by ConnDOT annually. The bridge replacement is scheduled to begin in spring 2009. Every effort must be made to keep the schedule.
